## Opportunity celebrates 10 years on Mars.

It keeps going and going and going – with maxon DC motors

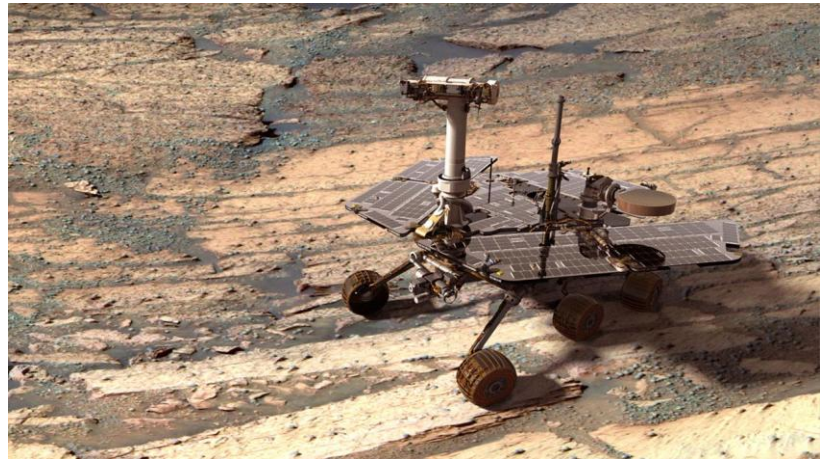
Fig. 1: Mars rover Opportunity. Image credit: NASA/JPL-Caltech

The rovers are six-wheeled, solar powered robots. Each wheel has its own maxon motor and they can also be found in the titanium robotic arm that has two joints at the shoulder, one at the elbow and two at the wrist, the grinding and brushing Rock Abrasion Tool (RAT), the numerous specialised on-board cameras, as well as the control mechanism.

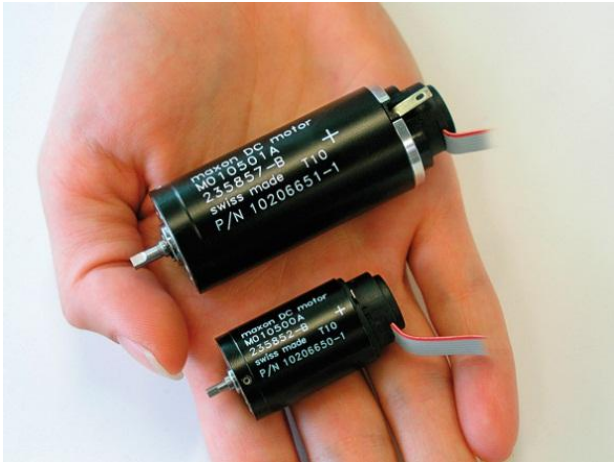
*Fig. 2: The RE 25 and RE 20 DC motors from maxon motor have been working on Mars for an entire decade.*

When the US space authority needed motors capable of dealing with the harsh Mars environment they chose to work with maxon motor. Maxon's standard DC motors, from the RE family, have had to cope with the demanding temperature fluctuations, between -120 °C and +25 °C, as well as extreme shock and high vibration. The motors have not failed despite long periods of being immobile and feature an efficiency of over 90 percent even in the dry, airless atmosphere of the Red Planet.
